Formerly Utilized Sites Remedial Action Program (FUSRAP) Contract No. DE-AC05-91OR21949

REMEDIAL INVESTIGATION REPORT FOR THE ST. LOUIS SITE

St. Louis, Missouri

January 1994

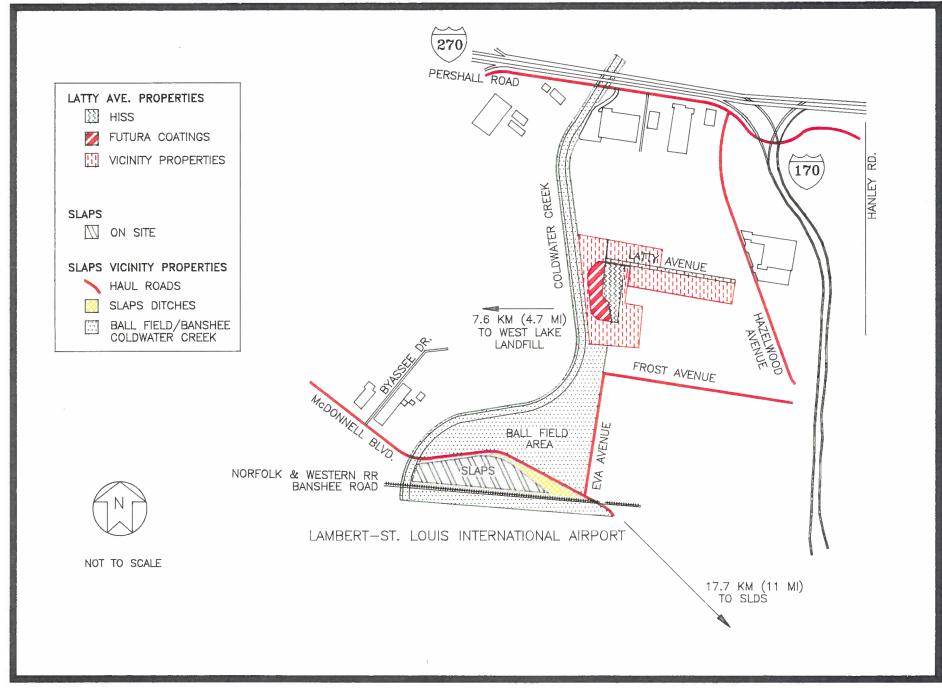
FIGURE 1-5 LOCATIONS OF SLAPS VICINITY PROPERTIES

SLAPS vicinity properties include Coldwater Creek and its vicinity properties to the west; adjacent ball fields to the north and east; Norfolk and Western Railroad properties adjacent to Coldwater Creek; Banshee Road to the south; ditches to the north and south; and St. Louis Airport Authority property to the south. Also included are the transportation routes: Latty Avenue, McDonnell Boulevard, Pershall Road, Hazelwood Avenue, Eva Avenue, Frost Avenue, and vicinity properties. These routes (referred to as the haul roads) are believed to have been used during waste transfer among the St. Louis properties. Figure 1-5 shows the locations of SLAPS vicinity properties.

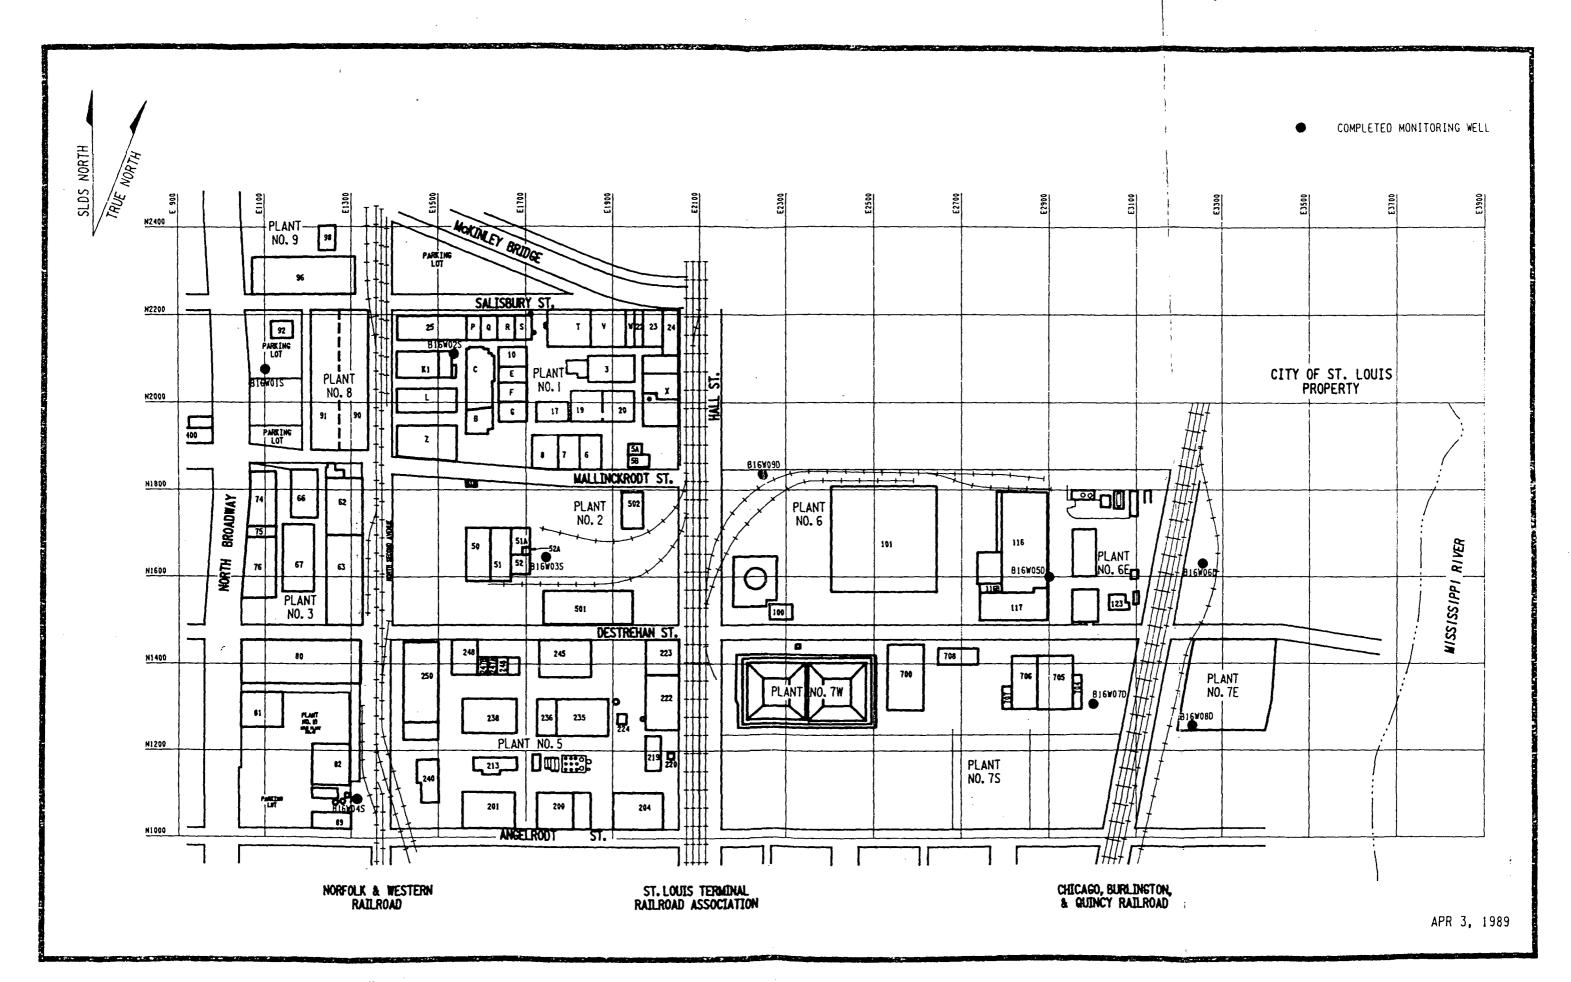
FIGURE 2-3 GROUNDWATER MONITORING WELL LOCATIONS AT SLDS

Groundwater sampling was conducted by purging the wells, decontaminating the bailer, and collecting the water sample. Purging ensures that fresh aquifer water enters the well, and decontamination of the sampling equipment ensures that no cross-contamination occurs between wells. The wells were purged by hand-bailing three casing volumes of water with a Teflon bailer.

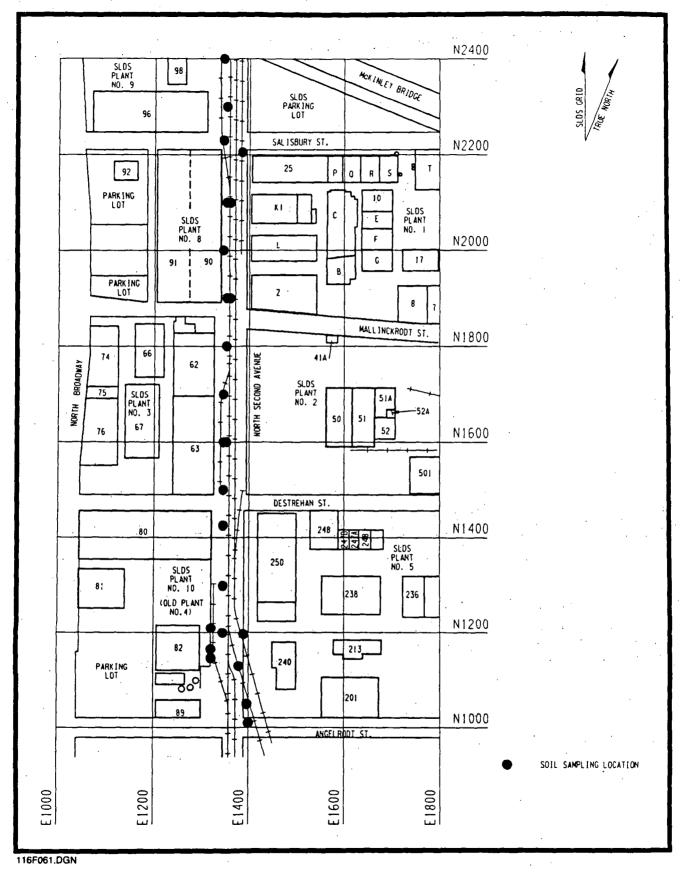
FIGURE 2-8 SOIL SAMPLING LOCATIONS AT THE NORFOLK AND WESTERN RAILROAD PROPERTY

The Norfolk and Western Railroad property is located in the western portion of SLDS. The property is a narrow strip of land running north and south, adjacent and parallel to North Second Avenue, and containing railroad tracks used for commercial transport. Thirty-four samples were collected from 24 locations (Figure 2-8).

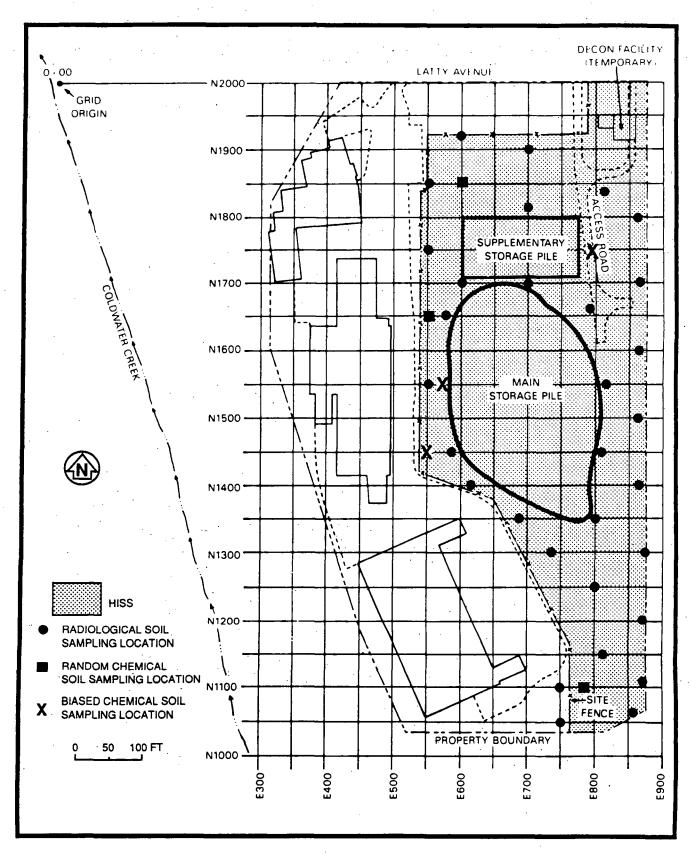
FIGURE 2-20 SOIL SAMPLING LOCATIONS AT HISS

Finally, surface and subsurface samples were collected at 30-cm (1-ft) intervals from 36 boreholes that were drilled to an average depth of 3 m (10 ft) (Figure 2-20). They were collected using either split-spoon samplers or appropriate hand-sampling tools. The soil samples were analyzed for uranium-238, radium-226, thorium-232, and thorium-230.

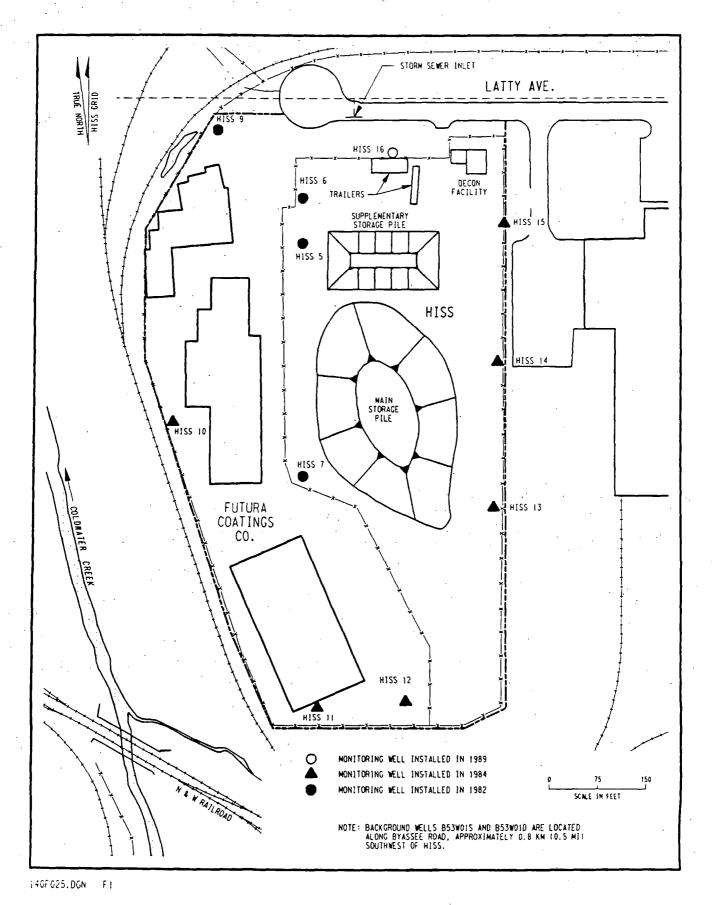
FIGURE 2-21 MONITORING WELL LOCATIONS AT HISS AND FUTURA

Samples have been collected quarterly from these seven wells and from two offsite background wells. Currently, Wells 5, 6, 7, 9, 10, 11, 12, 13, 14, 15, and 16 are used to monitor groundwater (four of these wells are actually located on the Futura property). Background wells are located at Byassee Road, approximately 0.8 km (0.5 mi) southwest of HISS. The unfiltered samples were collected in the same manner as those described in Subsection 2.1.1. All samples were analyzed for total uranium, radium-226, and thorium-230. In addition, the wells have been

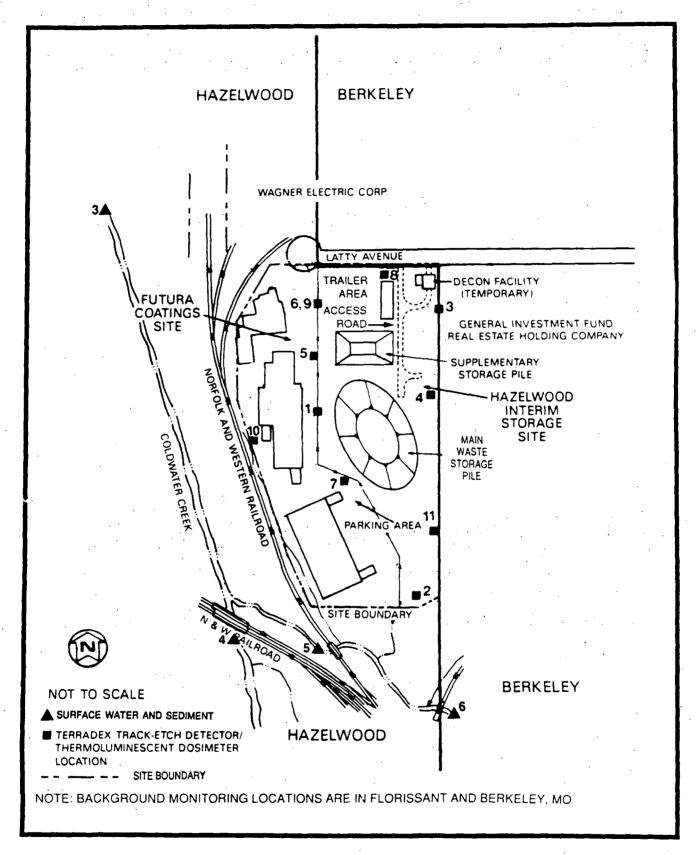
FIGURE 2-22 MONITORING LOCATIONS FOR RADON, EXTERNAL GAMMA RADIATION, SURFACE WATER, AND SEDIMENT AT HISS

Gamma exposure rates were also monitored around the HISS boundary and on each of the onsite storage piles using a PIC.

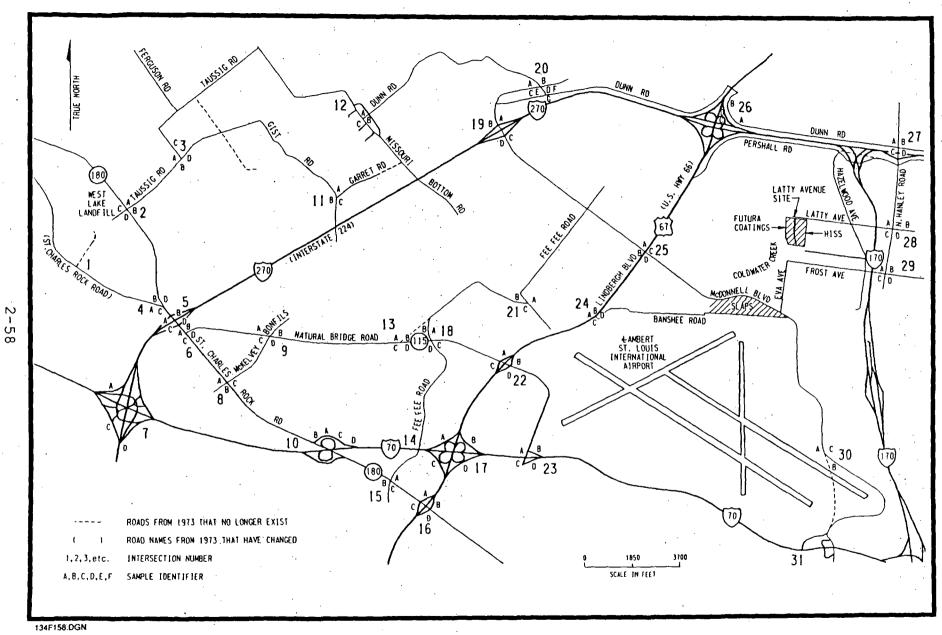
FIGURE 2-24 TRANSPORTATION ROUTES BETWEEN HISS AND WEST LAKE LANDFILL

A mobile gamma scanning van with an on-board computer system was used to identify possible anomalies on public roadways and suspected haul routes used to move wastes from HISS to West Lake Landfill and from SLDS to SLAPS. Public roadways, accessible commercial parking areas surrounding SLDS, and railroad crossings were also scanned. Some intersections and roads near the airport that were previously surveyed were investigated again (ORNL 1991).

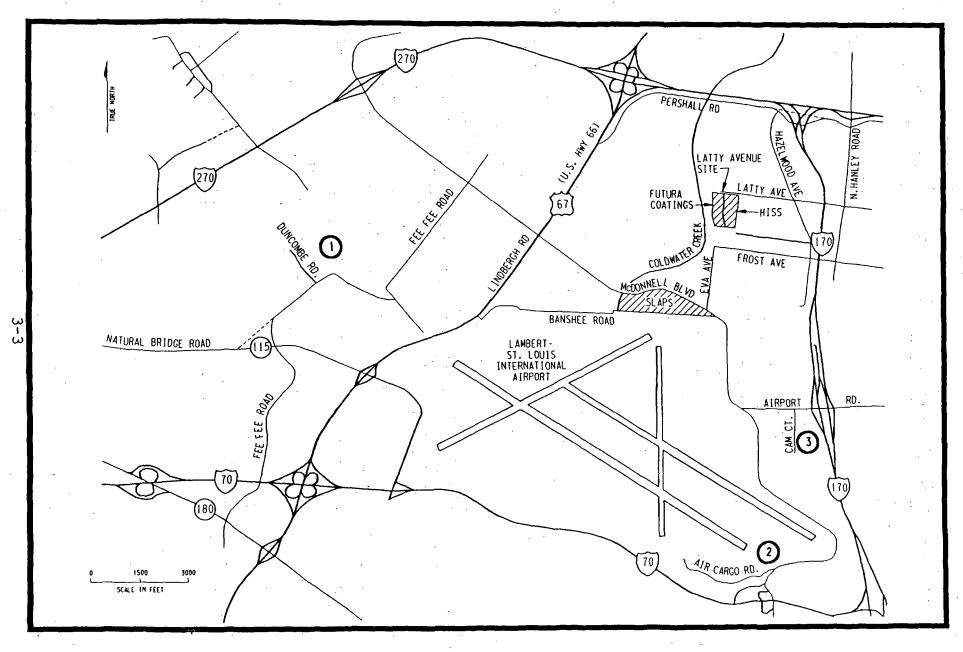
FIGURE 3-1 BACKGROUND SAMPLING LOCATIONS IN THE ST. LOUIS AREA

Groundwater background values were established at Byassee Road, approximately 0.8 km (0.5 mi) southwest of HISS and 2.4 km (1.5 mi) southwest of SLAPS. Concentrations of total uranium, radium-226, and thorium-230 range from less than 3 to 4, 0.6 to 1.1, and 0.2 to 0.4 pCi/L, respectively. Background concentrations for metals, VOCs, and BNAEs were not determined. Background values for groundwater indicator parameters are: pH - 6.8 to 7.3, TOC - 2.7

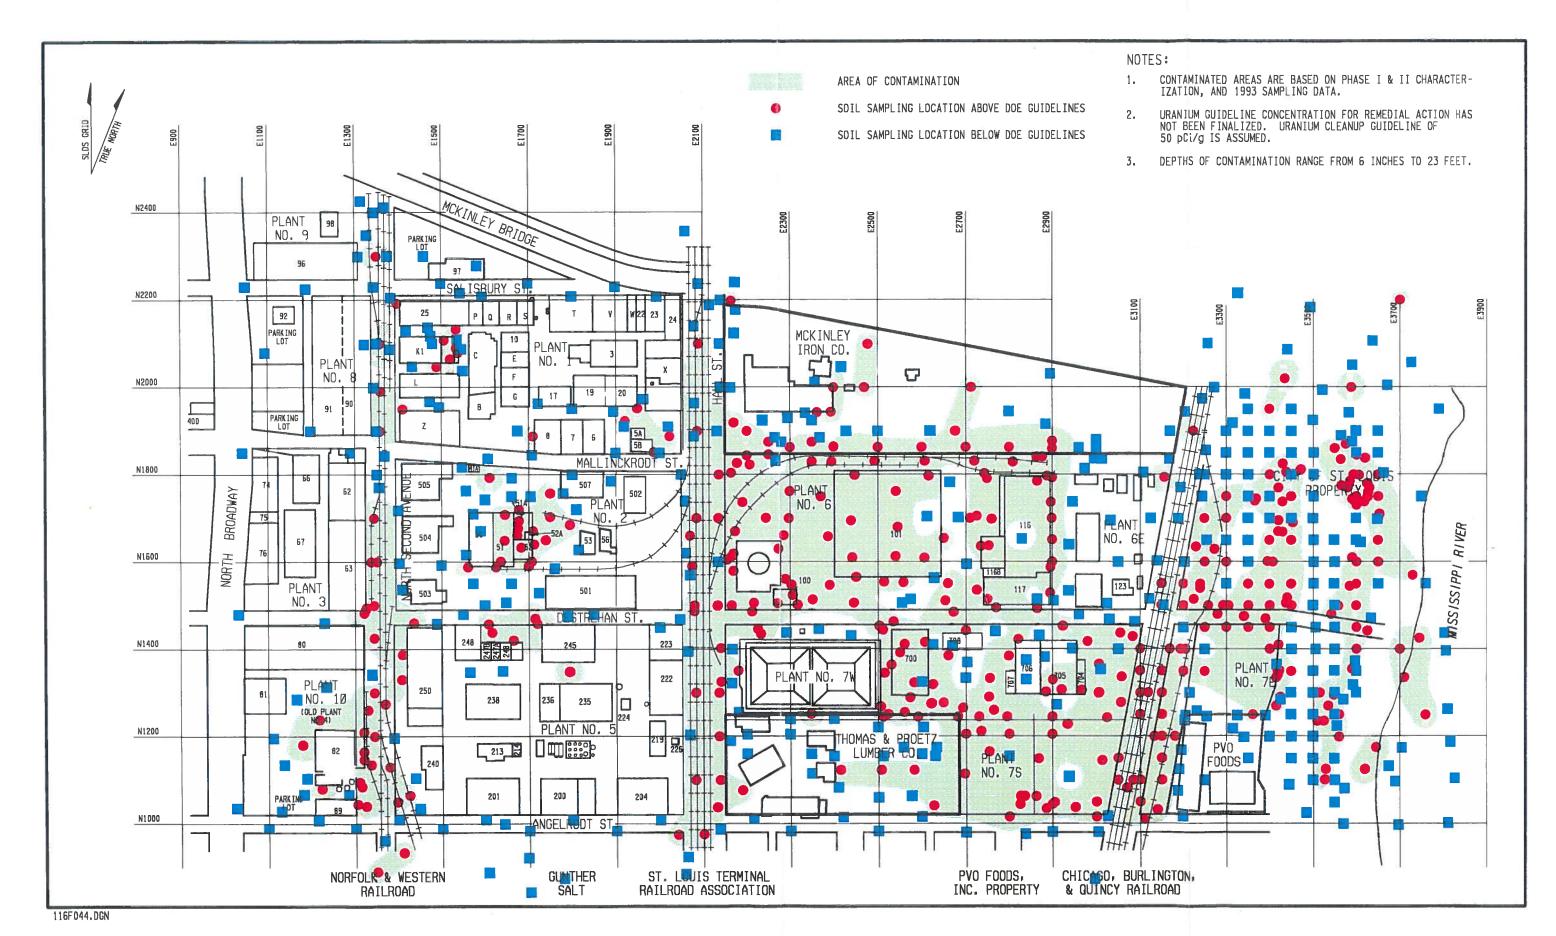
FIGURE 3-2 AREAS OF RADIOACTIVE CONTAMINATION AT SLDS

Radioactivity was found mostly in the rubble and fill zone and, in some instances, extending to undisturbed material. Uranium and metals, in general, are soluble in acidic environments such as those associated with decomposed organic materials found in the fill zone. These organic materials are very porous, which allows uranium-containing compounds to enter and react in the acidic environment. This reaction can allow the contaminants to migrate,

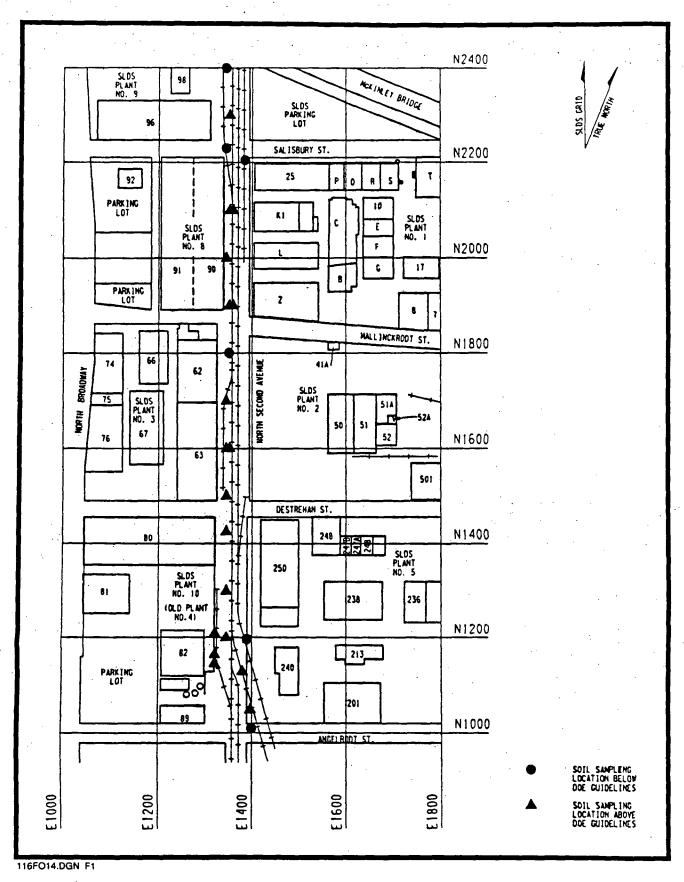
FIGURE 3-12 SOIL SAMPLING RESULTS FOR THE NORFOLK AND WESTERN RAILROAD PROPERTY

Eighteen of the 34 samples taken from 24 sampling locations at the Norfolk and Western Railroad property have radionuclide concentrations exceeding guidelines. These 18 samples were found along the entire length of the property (Figure 3-12).

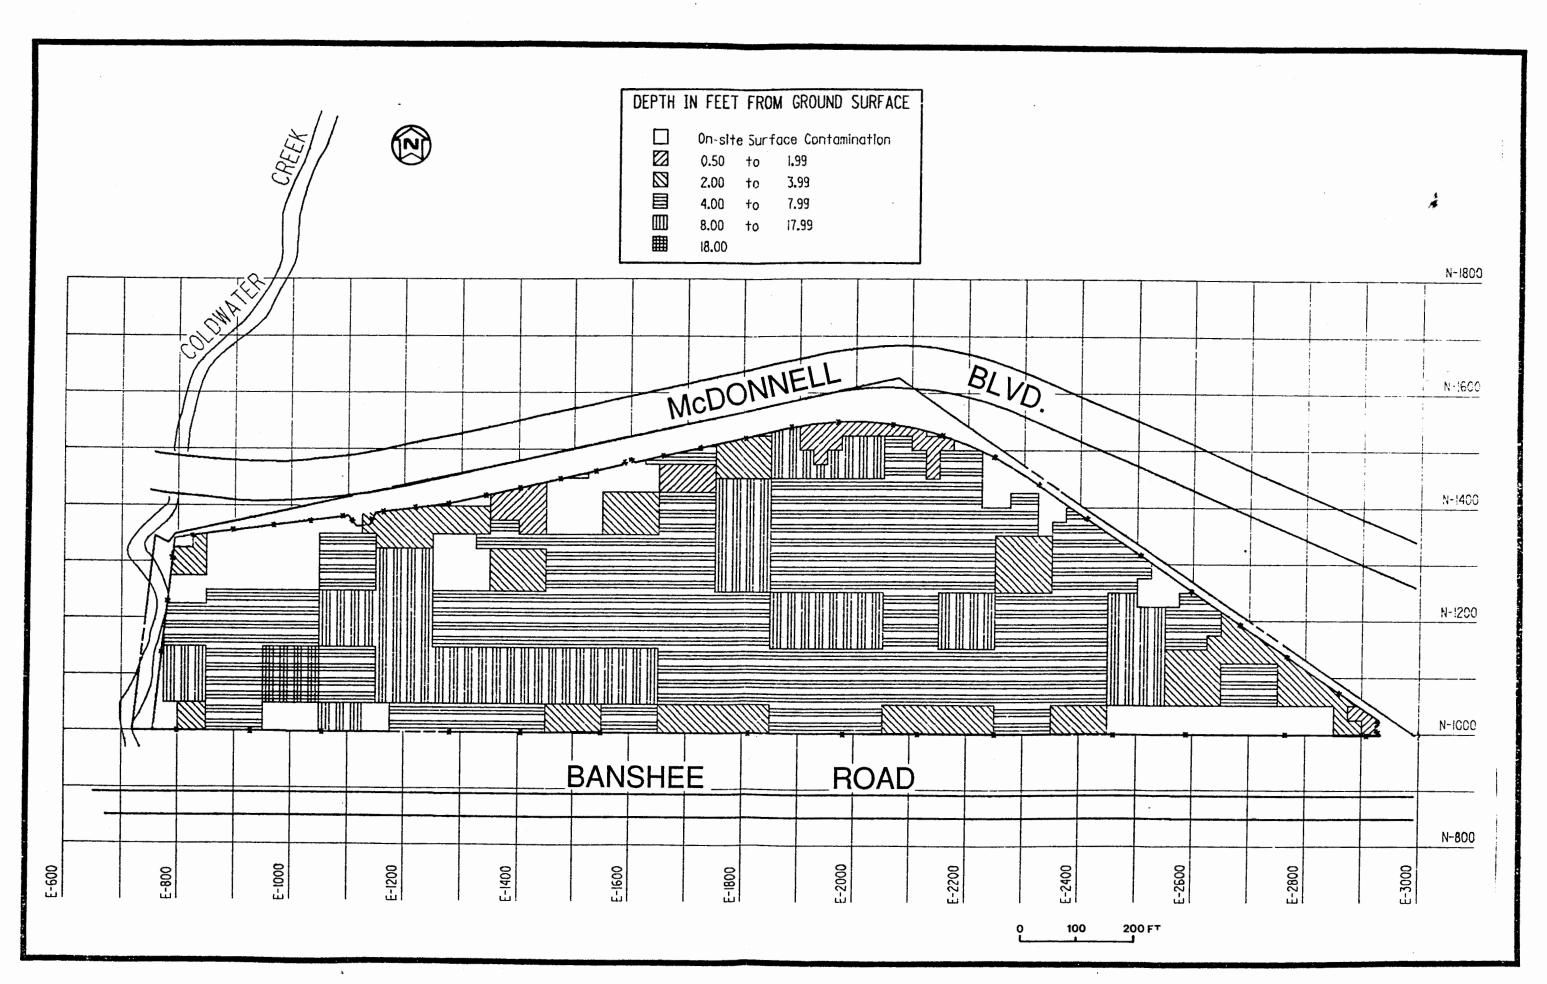
FIGURE 3-14 AREAS AND DEPTHS OF RADIOACTIVE CONTAMINATION AT SLAPS

Contamination was encountered at depths of up to 5.4 m (18 ft) during the soil investigation, but the contamination was generally found at 1.2 to 2.4 m (4 to 8 ft). Uranium-238, radium-226, thorium-230, and thorium-232 were found at elevated concentrations over the majority of the property. Uranium-238 concentrations range from less than 3 to 1,600 pCi/g with an average of 141 pCi/g. Radium-226 concentrations range from background levels to 5,620 pCi/g with an average of 61 pCi/g. Thorium-232 concentrations range from background levels to 63 pCi/g with an average of 4 pCi/g. Concentrations of thorium-230 range from 0.6 to 2,600 pCi/g with an average of 138 pCi/g. Approximately 250,000 yd³ (191,150 m³) of contaminated soil is present at SLAPS. The areas and depths of contamination are shown in Figure 3-14.

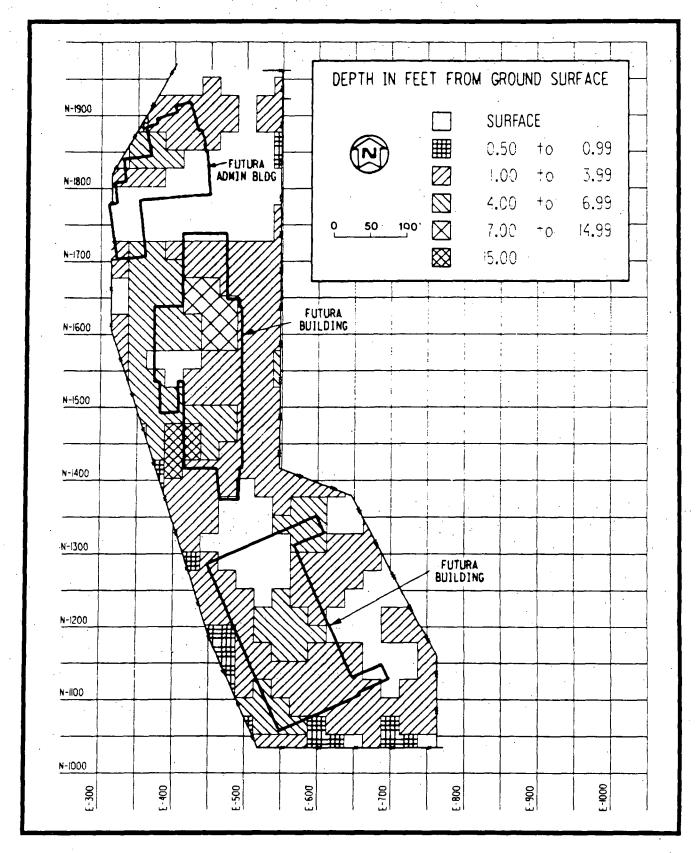
FIGURE 3-38 AREAS AND DEPTHS OF RADIOACTIVE CONTAMINATION AT THE FUTURA COATINGS PROPERTY

Analytical results for subsurface samples indicate no consistency in the depths of contamination based on systematic drilling. The depth of contamination ranges from the surface to approximately 4.6 m (15 ft). The variable depth of contamination can be attributed to the disturbance of soils caused by previous excavations and subsequent placement of fill material and to the natural variations in the topography of the property. The estimated volume of radioactively contaminated soil at Futura is approximately 25,996 m³ (34,000 yd³). Figure 3-38 shows the areas and depths of contamination.
